Tai & Chyun

Special Edition 2017

Case Studies

December Issue : Cement Industry

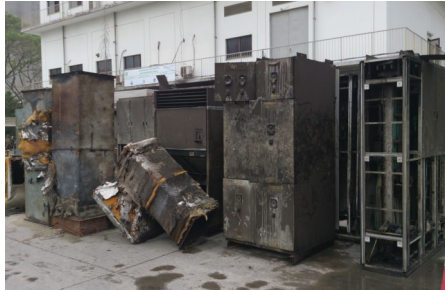
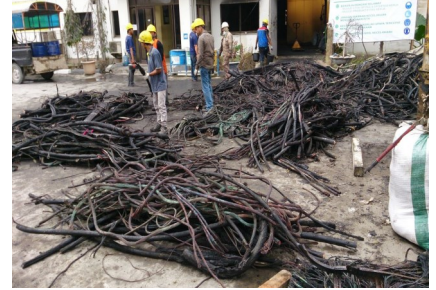
The control panel inside the cooler MCC room was totally burned out due to the short circuit that happened in the cable trench between cooler and raw mill. The power cables on the tray were also burned.

Burnt Control Panels and Wiring Cables removed from the Control Room

After the fire accident, Tai & Chyun's engineers immediately went on site for survey and measurement for new control panel. New control panels were requested to be designed, fabricated and transported to site within 8 weeks. Tai & Chyun sent electrical engineers for the installation and commissioning of the panels & controllers. The emergent recovery project was completed within three months, from on-site measurement, design, fabrication and 4 weeks for installation to commissioning in order to mitigate the plant's loss as much as possible. Other than the installation of the new control panels, maintenance jobs for auxiliary panel and PLC re-programming were also carried out.

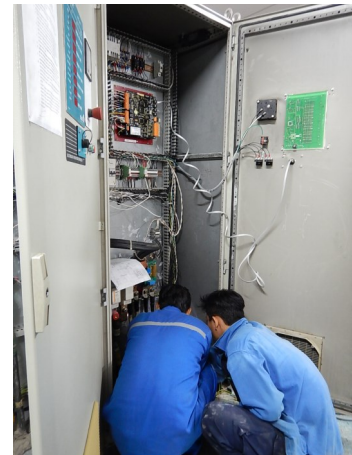
Installed Control Panels

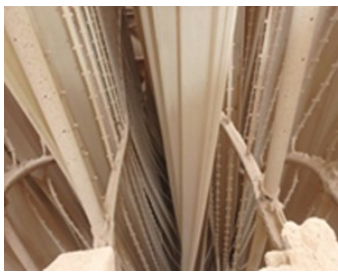
This ESP has been operated for about 7 years. Customer faced the serious problems with mechanical parts inside ESP such as falling down and bending parts, which caused a reduction in ESP collecting efficiency. This can lead further to the emission problem. Therefore, ESP mechanical revamping was implemented in order to improve ESP performance.

Bent CP

Accordingly, because of the poor mechanical condition inside ESP, we recommended customer to replace all the mechanical parts in all three fields of raw mill ESP in order to bring ESP back to normal condition.

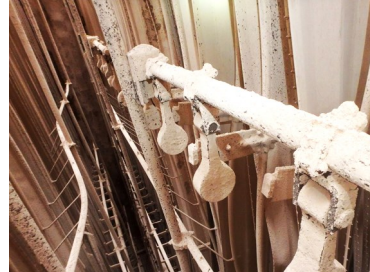
Missing Hammer

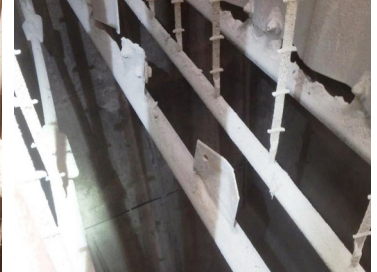
Missing CP

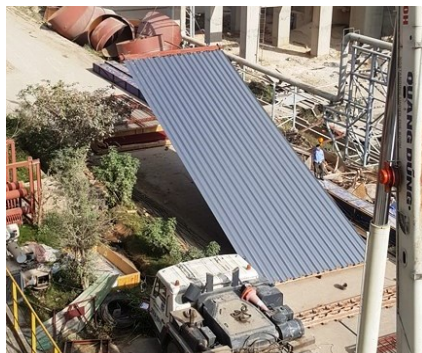
Lifting Up CP

Tai & Chyun was awarded a contract to execute the ESP mechanical revamping project. We provided the mechanical parts, together with supervision for the whole installation process.

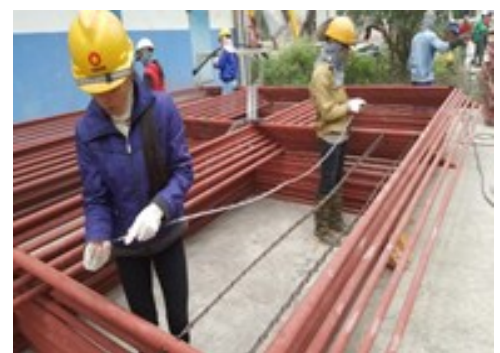
Inserting DE into Frame

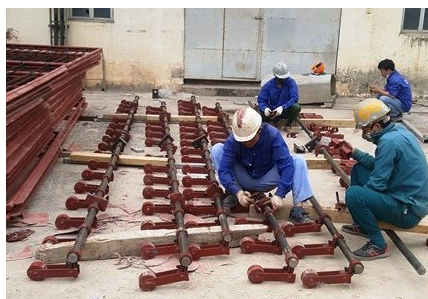
Installing Hammer

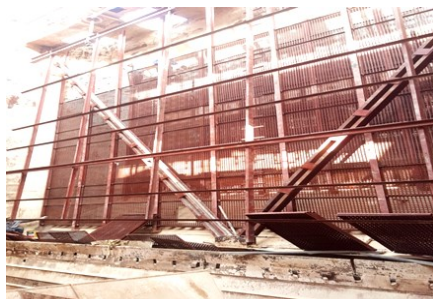
Installing GD Screen

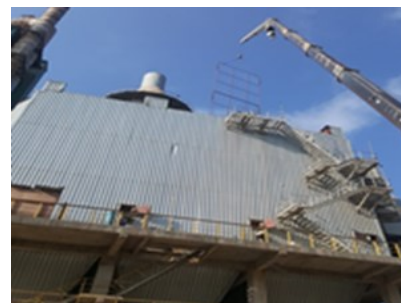
Lifting DE into ESP

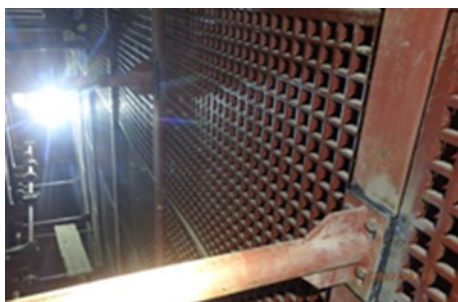
Newly Installed GD Screen

After the completion of ESP mechanical revamping project, it helped ESP to regain back to its normal condition with newly installed mechanical parts including CP, DE, GD screen & rapping assemblies.

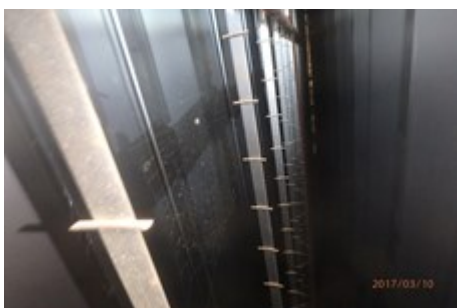
Newly Installed DE

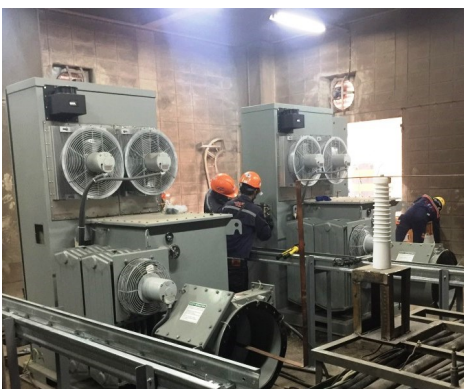
Installing HFTR

Tai & Chyun was awarded a contract to supply 2 fields of RDE and 4 fields of newly modified design of CP that is compatible with the old type, but with stronger interlock, together with two units of high frequency transformer (HFTR) installed at the ground level for 3rd and 4th field of ESP in order to improve the efficiency of high voltage output.

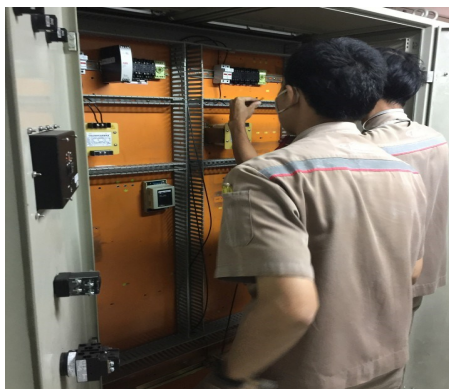
Installing Controller
(As part of HFTR Installation)

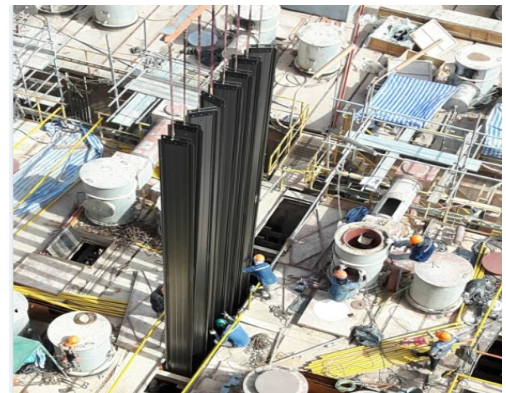
Installing CP

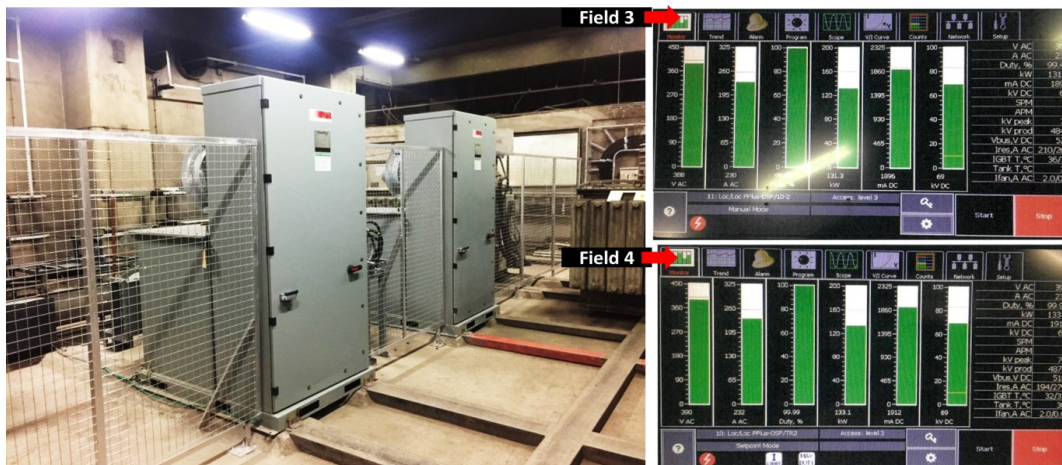
Installed HFTR in 3rd and 4th Field of ESP

In addition, the emission result also showed the value below 35 mg/Nm³, successfully fulfilling customer's requirement. Moreover, HFTR can be placed on the ground according to the current location of transformers, reducing the installation difficulty and bring convenient service to customer.

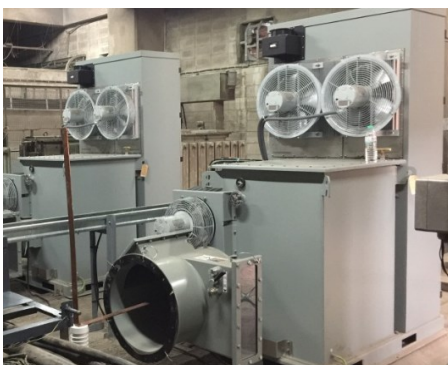
Installed HFTR

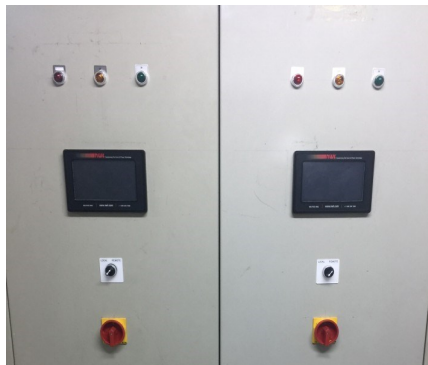
Installed Controller
